MSP430G2553 Device Erratasheet

1 Revision History

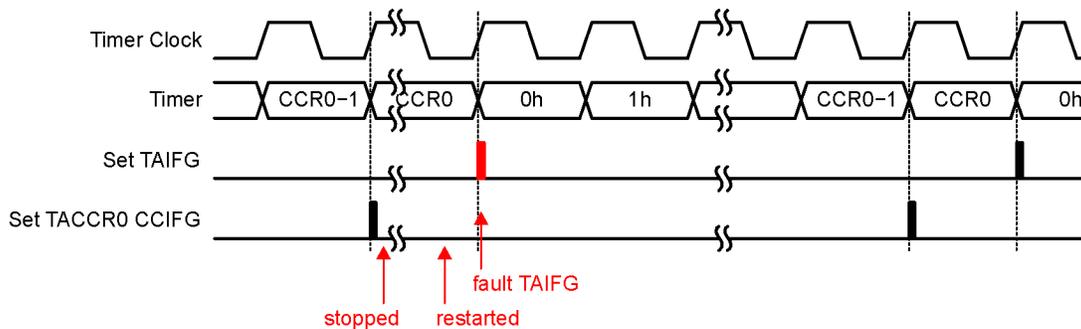
Function TAIFG Flag is erroneously set after Timer A restarts in Up Mode

Description In Up Mode, the TAIFG flag should only be set when the timer counts from TACCR0 to zero. However, if the Timer A is stopped at TAR = TACCR0, then cleared (TAR=0) by setting the TACLRL bit, and finally restarted in Up Mode, the next rising edge of the TACLK will erroneously set the TAIFG flag.

Workaround None.
