Reliability of Lightning Resistant Overhead Distribution Lines

Abstract — An assessment of the 32 year historical reliability of the 13.8 kV electrical distribution system at the Oak Ridge National Laboratory (ORNL) in Tennessee has yielded several conclusions useful in the planning of industrial power systems. The system configuration at ORNL has essentially remained unchanged in the last 32 years which allows a meaningful comparison of reliability trends for the plant's eight overhead distribution lines, two of which were built in the 1960's with lightning resistant construction techniques. Meticulous records indicating the cause, duration, and location of 135 electric outages in the plant's distribution system have allowed a reliability assessment to be performed. The assessment clearly shows how differences in voltage construction class, length, age, and maximum elevation above a reference elevation influence the reliability of overhead power distribution lines. Comparisons are also made between the ORNL historical data and predicted failure rates from ANSI and IEEE industry surveys.

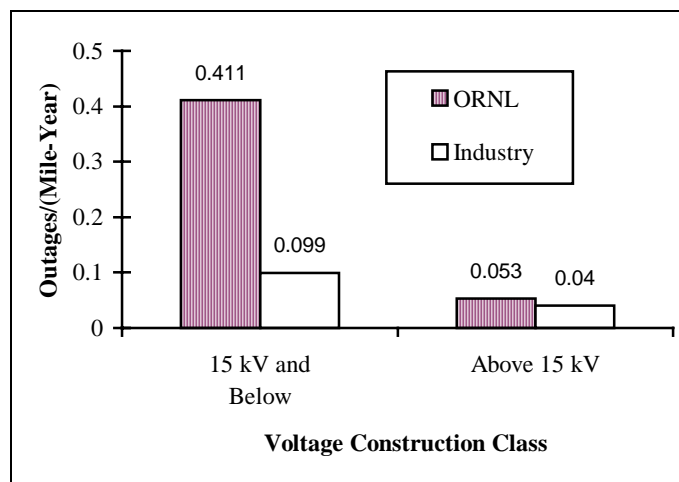
Fig. 1. Outages per Mile-Year Based on Insulation Level

Standard 493-1990 also presents failure rates for two subclasses of open wire installations (0-15 kV and above 15 kV) [3]. As can be seen from Fig. 1, failure rates for the 15 kV class ORNL feeders are over four times the industry average, which is indicative of the substantially higher percentage of lightning-induced failures noted in Table II.

However, the feeders employing lightning-resistant construction exhibit outage rates reasonably close to the industry average for the above 15 kV subclass. This comparison provides additional evidence supporting the effectiveness of these techniques in areas susceptible to frequent lightning.
