CCM Flyback: Ringing Due to L_1

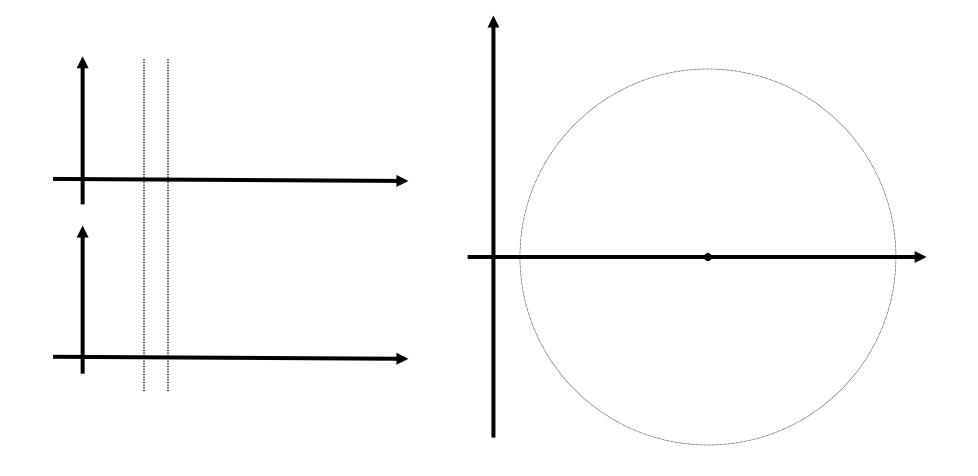
MOSFET Turn-off

Leakage Voltage Stress

Leakage Switching Loss

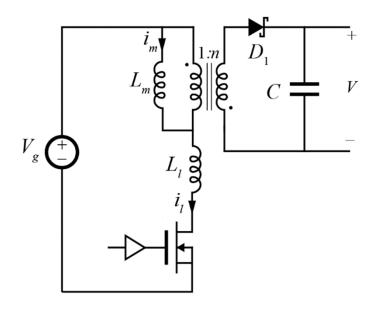
CCM Flyback: Clamping Circuit

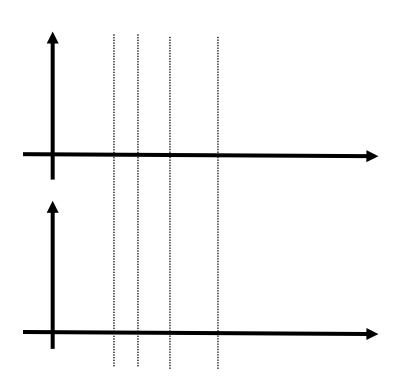
Clamped State Plane
