Synchrophasors at *OG/E*

Austin White P.E.

Oklahoma Gas & Electric Company

IEEE PES GM 2016

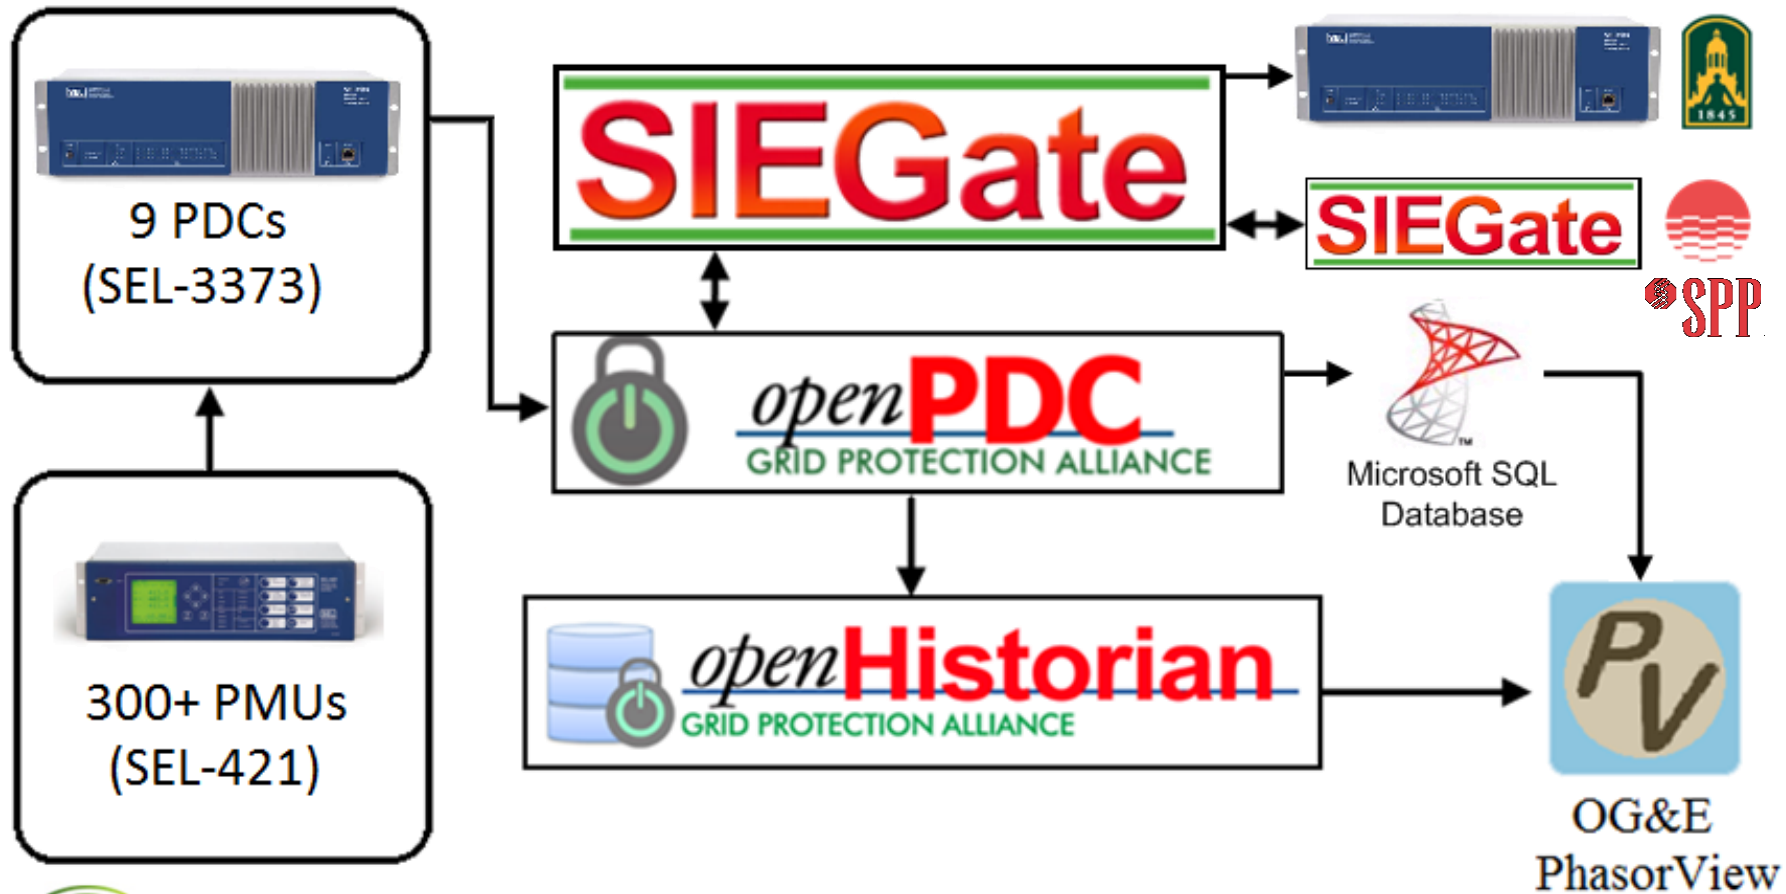
Simplified Architecture

- Protocols – C37.118 limited to ~150 PMUs, no security, frame based
- Performance – PDC limits are CPU burden starting at ~300 PMUs
- Data Storage – 350 PMUs, positive sequence need 15GB/day comp, 50GB uncompressed
- Network Bandwidth – Circuit needs 64kbps per PMU, no data caps, low latency

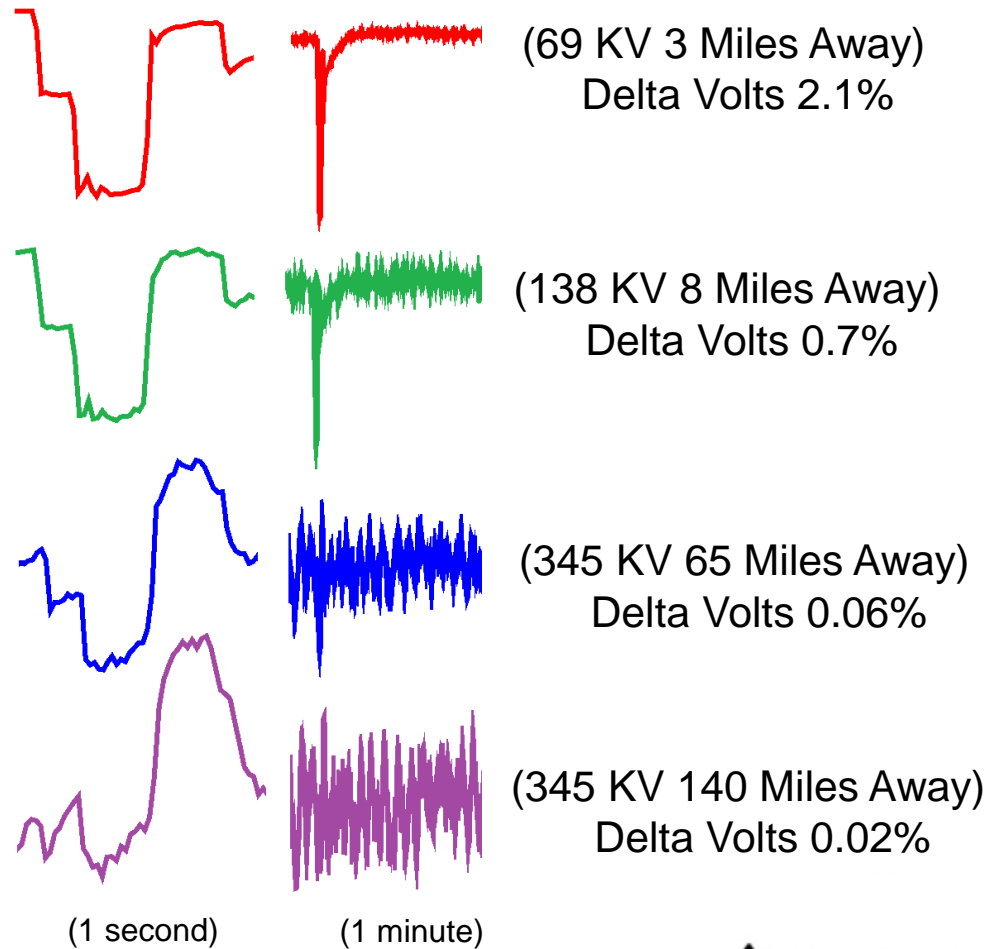
Fault Visibility

- 0.7 Second, 12.5kV Distribution Fault

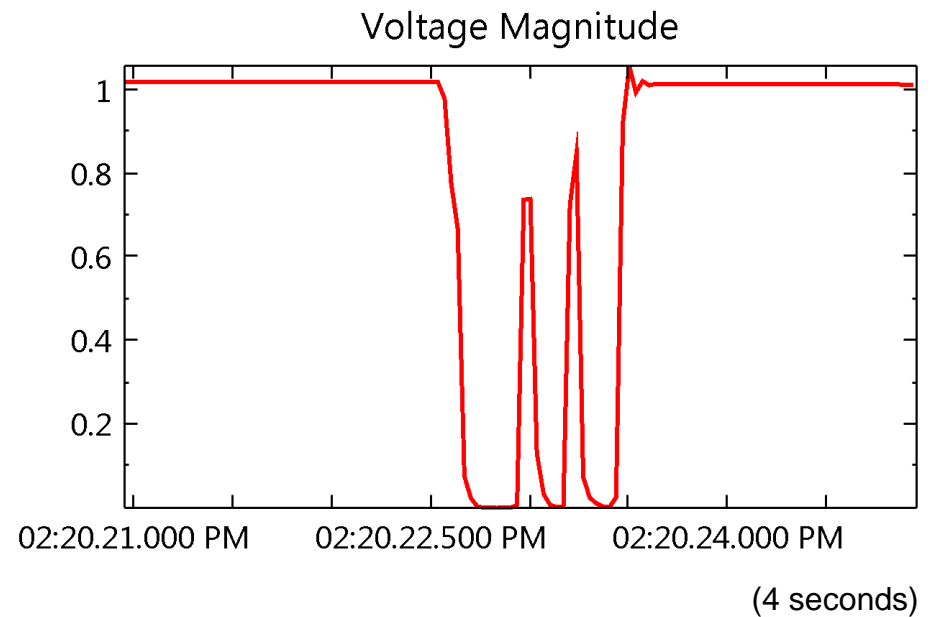
Failed EHV Reclosing Attempt

- Observed an unusual reclosing event following a fault on a 345kV line
- Able to diagnose multiple reclose attempts when only one reclose was expected
- Recent construction work changed the configuration
- Found that relay settings were not properly updated

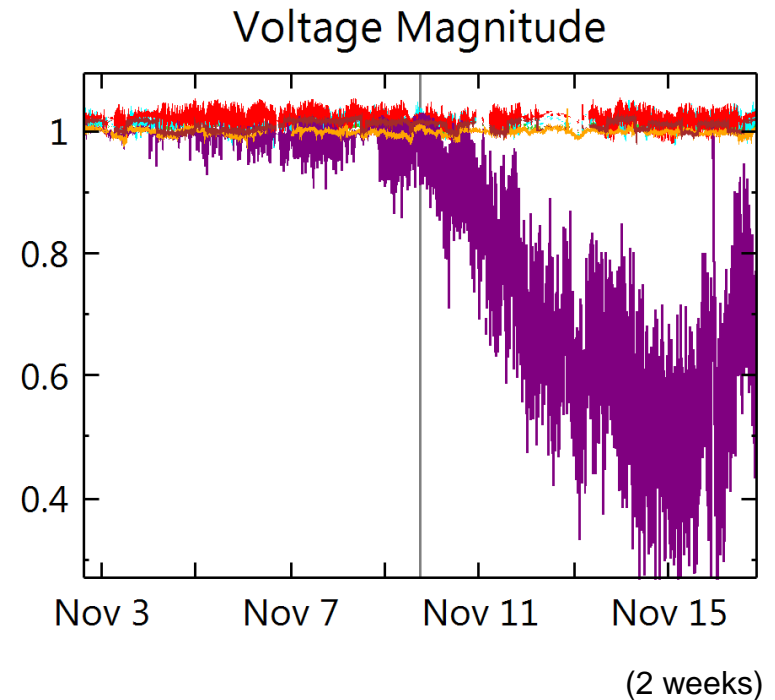
PT Problem Report

- Our daily PT Problem report performs a dV/dT to help identify abnormal voltage fluctuations

Failing analog input

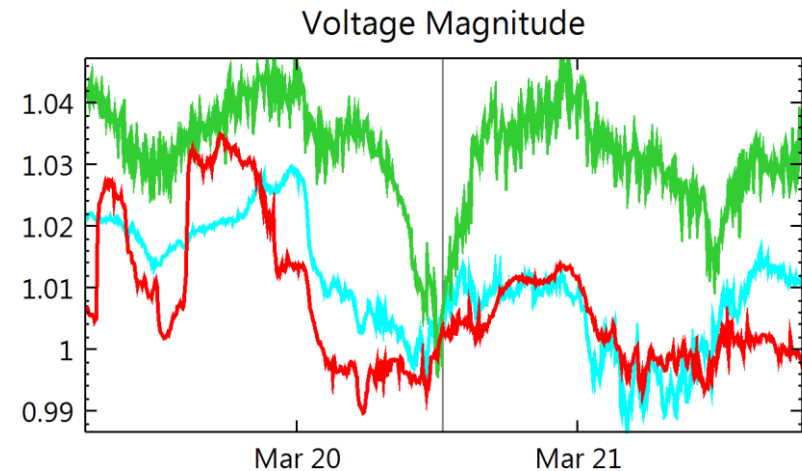
OG&E Wind Penetration > 4000MW

- SPP record peak of 45% and 10,783MW on 3/21/2016
- 60° angle spread across OG&E from west to east
