LIGHTNING-RESISTANT OVERHEAD LINES

Reliability of Lightning-Resistant Overhead Lines

Leon M. Tolbert, Lynn J. Degenhardt, and Jeff T. Cleveland

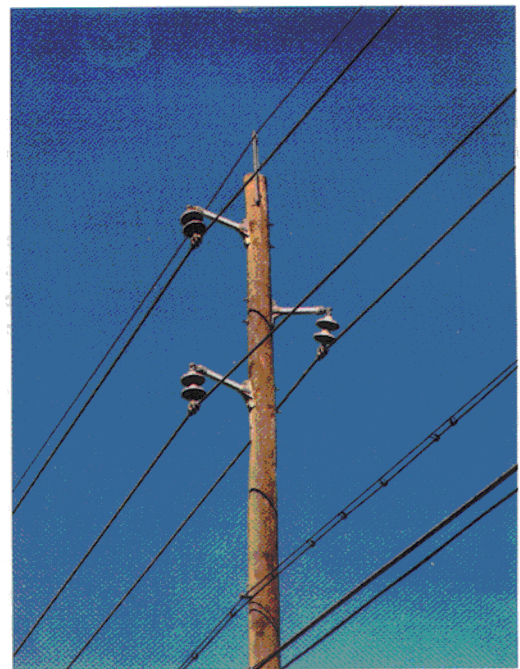
Fig. 2. A lightning-resistant pole structure with fiberglass suspension brackets, double ANSI 52-3 porcelain insulators, and an overhead ground wire.

In 1969, an overhead line (feeder 8) was intentionally built with "lightning-resistant" construction in an attempt to reduce lightning caused outages. Pole structures of the line have phase-over-phase 24-inch long fiberglass suspension brackets with double ANSI 52-3 porcelain suspension insulators to support the conductors (nominal 69 kV insulation). The shield angle of the overhead ground wire to the phase conductors for feeder 8 is typically 30 degrees. Figs. 2 and 3 depict two different lightning-resistant construction techniques.

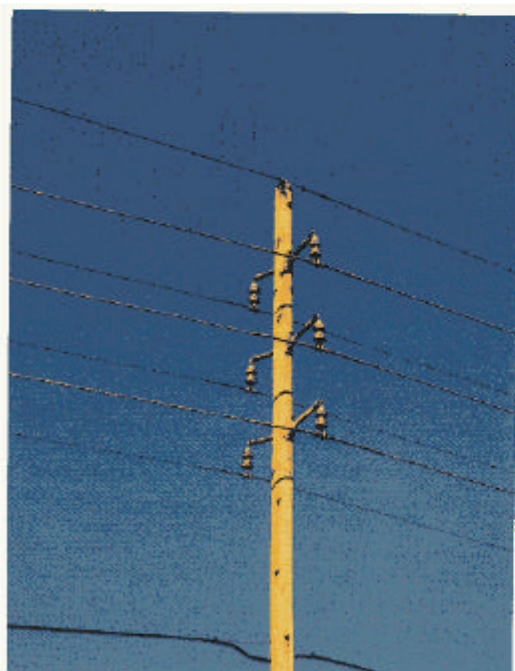
Fig. 3. An example of lightning-resistant construction techniques with two 3-phase feeders on one pole.

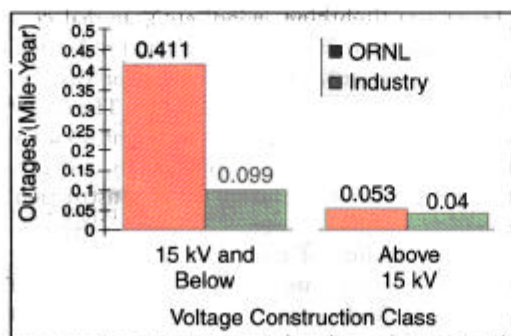
Fig. 4. Outages per mile-year based on insulation level.

Standard 493-1990 also presents failure rates for two subclasses of open wire installations (0-15 kV and above 15 kV) [3]. As can be seen from Fig. 4, failure rates for the 15 kV class ORNL feeders are over four times the industry average, which is indicative of the substantially higher percentage of lightning-induced failures noted in Table 2. However, the feeders employing lightning-resistant construction exhibit outage rates reasonably close to the industry average for the above 15 kV subclass. This comparison provides additional evidence supporting the effectiveness of these techniques in areas susceptible to frequent lightning.
