CCM Flyback: Ringing Due to L₁

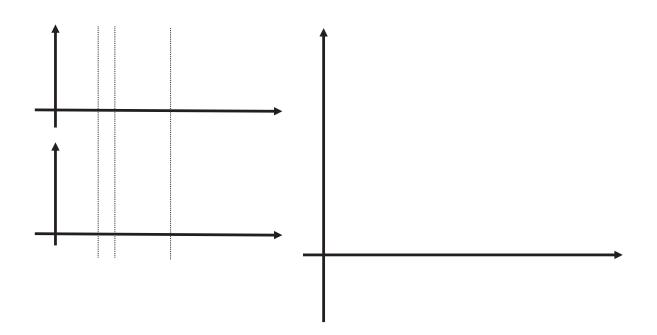
MOSFET Turn-off

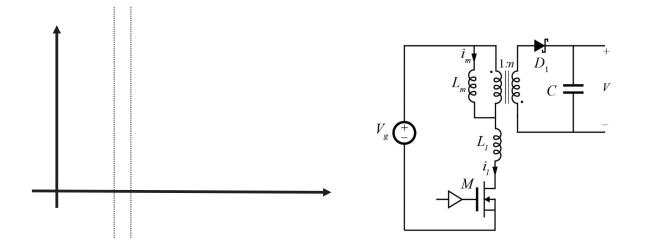
CCM Flyback: Clamping Circuit

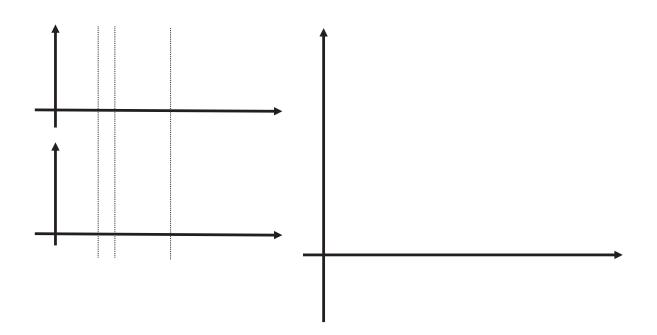
Clamped State Plane

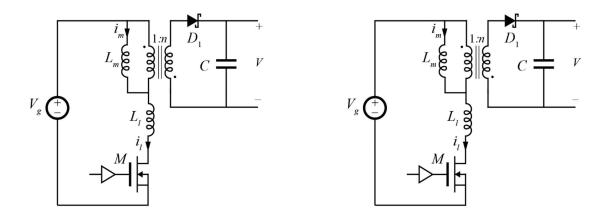
Snubber Implementations
